RESTORING THE **TANIGUCHI'S** FLOWING WATER IN AUSTIN, TEXAS

BY **ED PARKEN**

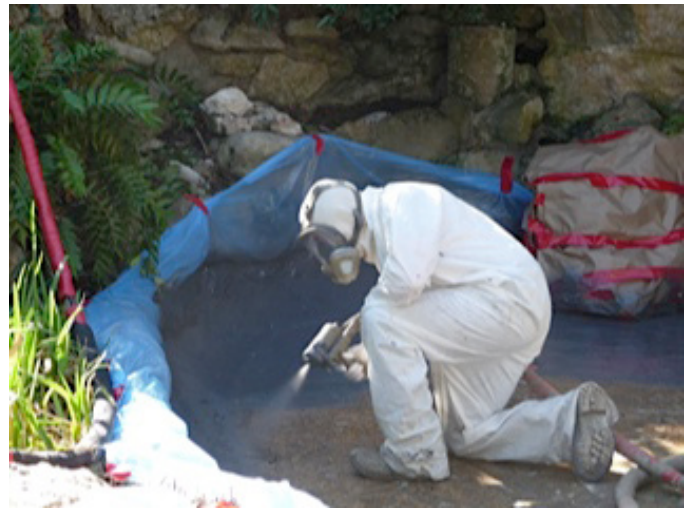
After carefully wrapping stones, pulling plants back, and masking edges by volunteers and park staff, the contractor finally had a dry day to apply the spray liner *Photo by Edward Parken for the Taniguchi Garden*

Next, the Lotus Pond was emptied, plants and decorative stones removed, and pond surfaces were sandblasted to remove previous coating material. The sandblasting work was completed December 2011. This was the largest pond to be sprayed with liner and there were many areas that required attention by the PARD staff. Holes and depressions had to be filled. Sharp corners had to be eliminated. Existing cracks

had to be filled and smoothed out. The contractor that applied the liner made a number of suggestions and the PARD staff did a thorough job preparing the entire pond.

The Patio Pond was completed in January, 2012. The Lotus Pond work turned out to be a challenge. The size of the Lotus Pond (2,627 ft. sq.) required that the application of the primer and the polyurea coating be applied in two steps. First the pond surfaces had to be dry. This meant that there had to be a period of four or five days without rain. The primer was applied first and then, after it was dry, the polyurea coating. The application of the polyurea had to be within twenty-four hours of the primer application. There was a period of very rainy weather and although we were happy that Austin was getting rain, it was difficult to find four or five dry days. After a number of false starts, the Lotus Pond was coated.

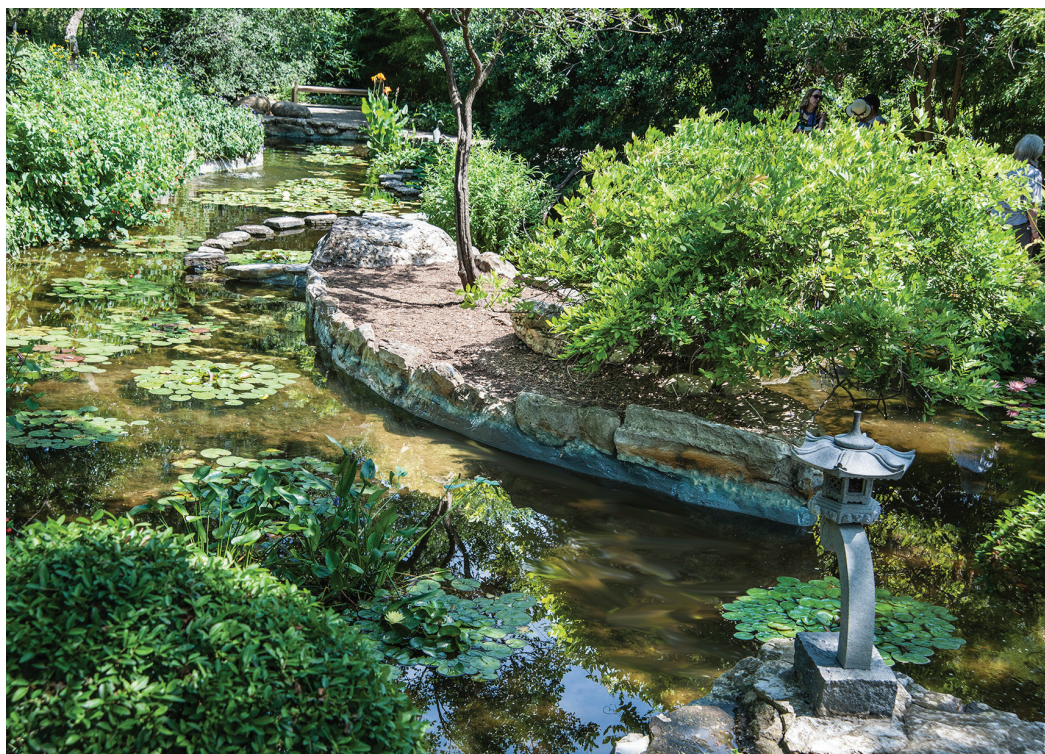
Lotus pond still filling after repairs and spray liner applied
Photo by Bill Eger

The ponds are in their best shape ever, with both stream beds and the pond surfaces completely stabilized and coated. The flowing water that gives such character to the Taniguchi is back. The koi are happy in the lotus pond. The waterfall is flowing down to the STIN pond once again. These repairs will reap benefits far into the future, with dramatically reduced water losses, much less maintenance, and enhanced beauty of the ponds.
